**Flood Control Project Maintenance  
Levee Inspections**

## Maintenance Issue Types Only, Levee Inspection Report By Mile - Spring 2018

### Sutter Maintenance Yard Maintenance Area 0012

Waterway	Bank	Unit Miles	Inspection Start/End	Inspector
Unit No. 01 Colusa Drain	Left	11.06	04/18/2018 04/18/2018	Bob Duffey

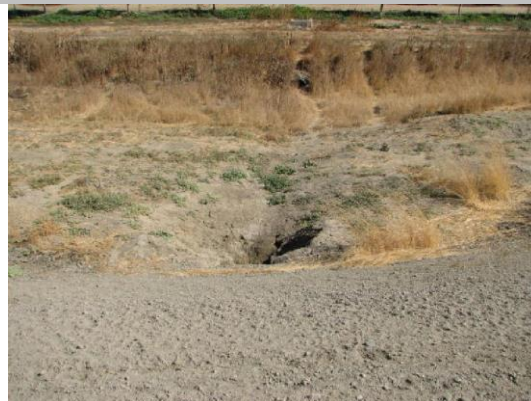
Photo 1 of 3 : UCIP\_SP\_2018\_51779\_68973.jpg

FS\_ID:51779  
DS\_ID:17146  
EP\_NO: 9382  
Repair Type: Non-Urgent  
Crossing Status: Found  
UCIP Comments: 5/2/2017 WS is in good condition. LS inlet is more than 50% full of sediment. Pipe needs to be cleaned internally. (DWR Sutter Yard- A Freitag)10/17/2016 Minor sediment blocking the WS flap gate from opening. LS inlet still mostly full of sediment.(DWR Sutter Yard- A Freitag)9/29/2016 Crossing has been downgraded from Urgent to Non-Urgent WS flap gate is closed for flood season. Need to coordinate with owner to remove sediment blocking WS flap gate. (DWR UCIP - omagana)5/31/2016 WS flap gate is blocked from opening by sediment. LS inlet is over 50% full of sediment. (DWR Sutter Yard - a Freitag)5/4/2015 WS flap gate is blocked by sediment and unable to open. LS inlet is about 50% plugged with soil. Needs to be cleaned. (DWR Sutter Yard - a Freitag)6/17/2014 Same as last inspection. (DWR Sutter Yard - a Freitag)12/16/2013 Sediment against flapgate has been cleared and it can now function properly. (DWR Sutter Yard - a Freitag)7/16/2013 Sediment is built up against WS flapgate preventing it from opening. (DWR Sutter Yard - a Freitag)10/11/2012 Pipe is partially filled with soil. (DWR UCIP - wwylyie)

Intake at LS toe.

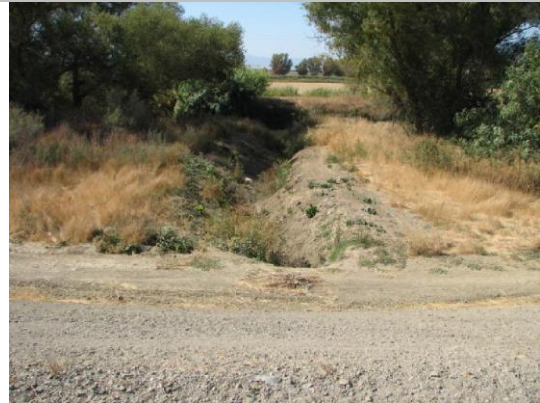
Photo 2 of 3 : UCIP\_SP\_2018\_51779\_68972.jpg

FS\_ID:51779  
DS\_ID:17146  
EP\_NO: 9382  
Repair Type: Non-Urgent  
Crossing Status: Found  
UCIP Comments: 5/2/2017 WS is in good condition. LS inlet is more than 50% full of sediment. Pipe needs to be cleaned internally. (DWR Sutter Yard- A Freitag)10/17/2016 Minor sediment blocking the WS flap gate from opening. LS inlet still mostly full of sediment.(DWR Sutter Yard- A Freitag)9/29/2016 Crossing has been downgraded from Urgent to Non-Urgent WS flap gate is closed for flood season. Need to coordinate with owner to remove sediment blocking WS flap gate. (DWR UCIP - omagana)5/31/2016 WS flap gate is blocked from opening by sediment. LS inlet is over 50% full of sediment. (DWR Sutter Yard - a Freitag)5/4/2015 WS flap gate is blocked by sediment and unable to open. LS inlet is about 50% plugged with soil. Needs to be cleaned. (DWR Sutter Yard - a Freitag)6/17/2014 Same as last inspection. (DWR Sutter Yard - a Freitag)12/16/2013 Sediment against flapgate has been cleared and it can now function properly. (DWR Sutter Yard - a Freitag)7/16/2013 Sediment is built up against WS flapgate preventing it from opening. (DWR Sutter Yard - a Freitag)10/11/2012 Pipe is partially filled with soil. (DWR UCIP - wwylye)

Outlet at WS toe.

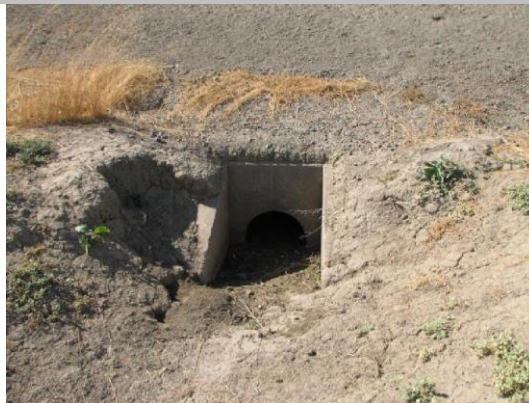
Photo 3 of 3 : UCIP\_SP\_2018\_51779\_68971.jpg

FS\_ID:51779  
DS\_ID:17146  
EP\_NO: 9382  
Repair Type: Non-Urgent  
Crossing Status: Found  
UCIP Comments: 5/2/2017 WS is in good condition. LS inlet is more than 50% full of sediment. Pipe needs to be cleaned internally. (DWR Sutter Yard- A Freitag)10/17/2016 Minor sediment blocking the WS flap gate from opening. LS inlet still mostly full of sediment.(DWR Sutter Yard- A Freitag)9/29/2016 Crossing has been downgraded from Urgent to Non-Urgent WS flap gate is closed for flood season. Need to coordinate with owner to remove sediment blocking WS flap gate. (DWR UCIP - omagana)5/31/2016 WS flap gate is blocked from opening by sediment. LS inlet is over 50% full of sediment. (DWR Sutter Yard - a Freitag)5/4/2015 WS flap gate is blocked by sediment and unable to open. LS inlet is about 50% plugged with soil. Needs to be cleaned. (DWR Sutter Yard - a Freitag)6/17/2014 Same as last inspection. (DWR Sutter Yard - a Freitag)12/16/2013 Sediment against flapgate has been cleared and it can now function properly. (DWR Sutter Yard - a Freitag)7/16/2013 Sediment is built up against WS flapgate preventing it from opening. (DWR Sutter Yard - a Freitag)10/11/2012 Pipe is partially filled with soil. (DWR UCIP - wwylie)

Inlet and concrete headwall on LS toe.

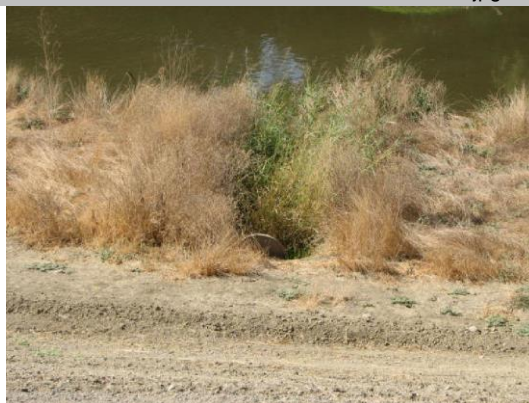
Photo 1 of 3 : UCIP\_SP\_2018\_51782\_68984.jpg

FS\_ID:51782  
DS\_ID:17149  
EP\_NO: 9382  
Repair Type: Non-Urgent  
Crossing Status: Found  
UCIP Comments: 5/2/2017 WS flapgate buried by sediment. Needs to be dug out. (DWR Sutter Yard- A Freitag)10/17/2016 Crossing appears to be in good condition. This is a gravity drain for the LS. (DWR Sutter Yard- A Freitag)5/31/2016 LS inlets was partially plugged. WS flapgate was clear of sediment and abale to operate properly.5/4/2015 WS flapgate is blocked by sediment and unable to open. LS inlet is plugged by silt and wood chippings. Needs to be cleaned.6/17/2014 Flap gate was cleaned out and is fully closed. LS inlet still partially full of soil.12/16/2013 Same as last inspection. WS flapgate still needs to be cleaned out and shut.7/16/2013 Same as last inspection. Make sure flapgate is closed before highwater season.10/11/2012 Inlet on LS filled partially with soil. Outlet blocked with soil and the flap gate wont close.

Outlet on WS toe.

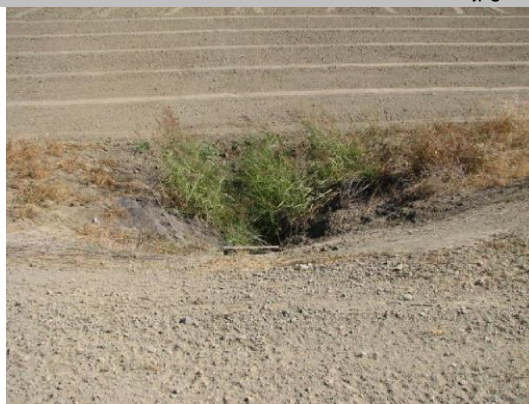
Photo 2 of 3 : UCIP\_SP\_2018\_51782\_68983.jpg

Inlet on LS toe.

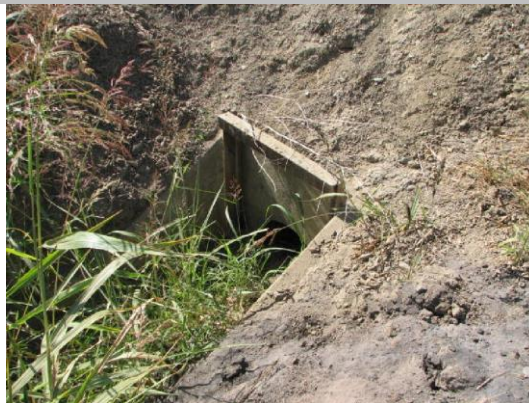
Photo 3 of 3 : UCIP\_SP\_2018\_51782\_68982.jpg

FS\_ID:51782  
DS\_ID:17149  
EP\_NO: 9382  
Repair Type: Non-Urgent  
Crossing Status: Found  
UCIP Comments: 5/2/2017 WS flapgate buried by sediment. Needs to be dug out. (DWR Sutter Yard- A Freitag)10/17/2016 Crossing appears to be in good condition. This is a gravity drain for the LS. (DWR Sutter Yard- A Freitag)5/31/2016 LS inlets was partially plugged. WS flapgate was clear of sediment and abale to operate properly.5/4/2015 WS flapgate is blocked by sediment and unable to open. LS inlet is plugged by silt and wood chippings. Needs to be cleaned.6/17/2014 Flap gate was cleaned out and is fully closed. LS inlet still partially full of soil.12/16/2013 Same as last inspection. WS flapgate still needs to be cleaned out and shut.7/16/2013 Same as last inspection. Make sure flapgate is closed before highwater season.10/11/2012 Inlet on LS filled partially with soil. Outlet blocked with soil and the flap gate wont close.

Concrete U shaped headwall at LS inlet.

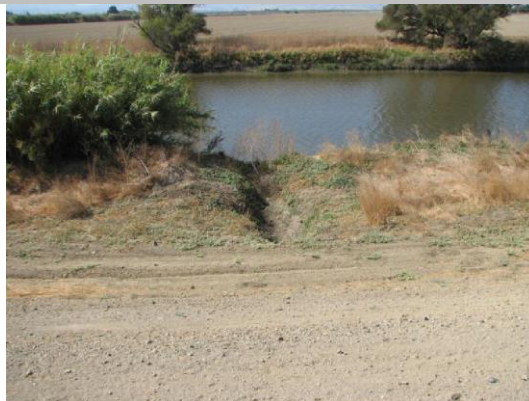
Photo 1 of 3 : UCIP\_SP\_2018\_51786\_68994.jpg

FS\_ID:51786  
DS\_ID:17151  
EP\_NO: 9391  
Repair Type: Non-Urgent  
Crossing Status: Found  
UCIP Comments: 5/2/2017 Both ends of pipe buried. (DWR Sutter Yard- AFreitag)10/17/2016 Appears abandoned. Both pipe ends are completely buried. (DWR Sutter Yard- AFreitag)9/29/2016 Crossing has been downgraded from Urgent to Non-Urgent both pipe ends are buried. Having both ends buried prevents water from flowing from WS to LS during flood season. Need to contact owner and have owner coordinate with CVFPB to comply with Title 23. (DWR UCIP - omagana)5/31/2016 Both pipe ends are buried. Pipe is non-operational. (DWR Sutter Yard - afreitag)5/4/2015 LS and WS ends are blocked with soil. Pipe is inoperable as it is. (DWR Sutter Yard - afreitag)6/17/2014 Same as last inspection. (DWR Sutter Yard - afreitag)12/16/2013 Same as last inspection. (DWR Sutter Yard - afreitag)7/16/2013 LS inlet is completely filled with soil. Needs to be cleaned out. (DWR Sutter Yard - afreitag)10/11/2012 Inlet is partially filled with soil. (DWR Sutter Yard - wwylie)

WS view of outlet.

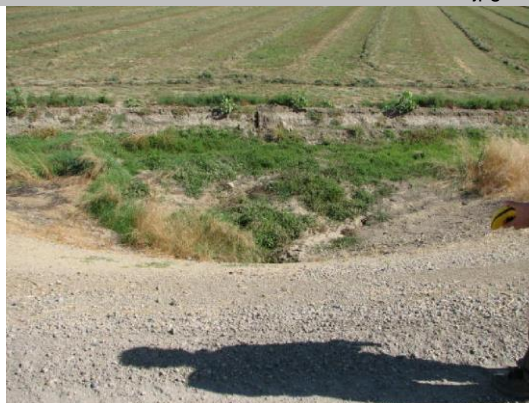
Photo 2 of 3 : UCIP\_SP\_2018\_51786\_68993.jpg

FS\_ID:51786  
DS\_ID:17151  
EP\_NO: 9391  
Repair Type: Non-Urgent  
Crossing Status: Found  
UCIP Comments: 5/2/2017 Both ends of pipe buried. (DWR Sutter Yard- A Freitag)10/17/2016 Appears abandoned. Both pipe ends are completely buried. (DWR Sutter Yard- A Freitag)9/29/2016 Crossing has been downgraded from Urgent to Non-Urgent both pipe ends are buried. Having both ends buried prevents water from flowing from WS to LS during flood season. Need to contact owner and have owner coordinate with CVFPB to comply with Title 23. (DWR UCIP - omagana)5/31/2016 Both pipe ends are buried. Pipe is non-operational. (DWR Sutter Yard - a Freitag)5/4/2015 LS and WS ends are blocked with soil. Pipe is inoperable as it is. (DWR Sutter Yard - a Freitag)6/17/2014 Same as last inspection. (DWR Sutter Yard - a Freitag)12/16/2013 Same as last inspection. (DWR Sutter Yard - a Freitag)7/16/2013 LS inlet is completely filled with soil. Needs to be cleaned out. (DWR Sutter Yard - a Freitag)10/11/2012 Inlet is partially filled with soil. (DWR Sutter Yard - wylie)

LS view of inlet.

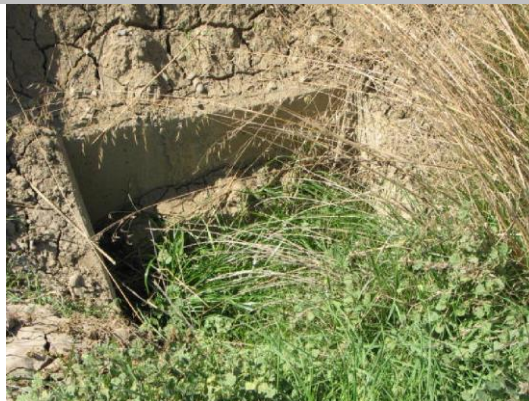
Photo 3 of 3 : UCIP\_SP\_2018\_51786\_68992.jpg

FS\_ID:51786  
DS\_ID:17151  
EP\_NO: 9391  
Repair Type: Non-Urgent  
Crossing Status: Found  
UCIP Comments: 5/2/2017 Both ends of pipe buried. (DWR Sutter Yard- A Freitag)10/17/2016 Appears abandoned. Both pipe ends are completely buried. (DWR Sutter Yard- A Freitag)9/29/2016 Crossing has been downgraded from Urgent to Non-Urgent both pipe ends are buried. Having both ends buried prevents water from flowing from WS to LS during flood season. Need to contact owner and have owner coordinate with CVFPB to comply with Title 23. (DWR UCIP - omagana)5/31/2016 Both pipe ends are buried. Pipe is non-operational. (DWR Sutter Yard - a Freitag)5/4/2015 LS and WS ends are blocked with soil. Pipe is inoperable as it is. (DWR Sutter Yard - a Freitag)6/17/2014 Same as last inspection. (DWR Sutter Yard - a Freitag)12/16/2013 Same as last inspection. (DWR Sutter Yard - a Freitag)7/16/2013 LS inlet is completely filled with soil. Needs to be cleaned out. (DWR Sutter Yard - a Freitag)10/11/2012 Inlet is partially filled with soil. (DWR Sutter Yard - wylie)

Concrete U shaped headwall at LS toe.

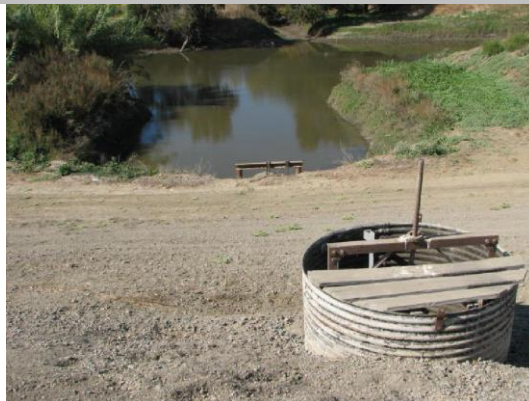
Photo 1 of 3 : UCIP\_SP\_2018\_51789\_69005.jpg

FS\_ID:51789  
DS\_ID:17154  
EP\_NO: 9388  
Repair Type: Urgent  
Crossing Status: Found  
UCIP Comments: 5/2/2017 WS slidegate stem is still bent, wheel to operate gate is missing. Needs a cover made for the standpipe to prevent falls. (DWR Sutter Yard- A Freitag)10/17/2016 Slide gate stem is still bent and the gate appears to be inoperable. (DWR Sutter Yard- A Freitag)5/31/2016 Slide gate stem is still bent. WS flap gate is chained open. (DWR Sutter Yard - A Freitag)5/4/2015 Slide gate stem is still bent. Gate looks to be unable to close all the way. (DWR Sutter Yard - A Freitag)6/17/2014 Same as last inspection. (DWR Sutter Yard - A Freitag)12/16/2013 Slide gate stem is still bent. WS flapgate was closed. (DWR Sutter Yard - A Freitag)7/16/2013 Water flowing through pipe so screw gate definitely not closed. Was told NOV's have been sent for owner to replace stem. Flap gate gets closed for flood season. (DWR Sutter Yard - A Freitag)10/11/2012 Slide gate inoperable, but appears to be in closed position. Flap gate held in open position. Good candidate for video inspection when, if ever, dry. (DWR UCIP - Wylie)

Slide gate in corrugated metal riser on WS slope.

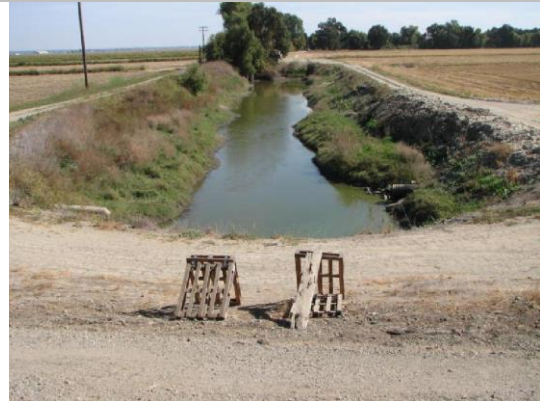
Photo 2 of 3 : UCIP\_SP\_2018\_51789\_69004.jpg

FS\_ID:51789  
DS\_ID:17154  
EP\_NO: 9388  
Repair Type: Urgent  
Crossing Status: Found  
UCIP Comments: 5/2/2017 WS slidegate stem is still bent, wheel to operate gate is missing. Needs a cover made for the standpipe to prevent falls. (DWR Sutter Yard- A Freitag)10/17/2016 Slide gate stem is still bent and the gate appears to be inoperable. (DWR Sutter Yard- A Freitag)5/31/2016 Slide gate stem is still bent. WS flap gate is chained open. (DWR Sutter Yard - A Freitag)5/4/2015 Slide gate stem is still bent. Gate looks to be unable to close all the way. (DWR Sutter Yard - A Freitag)6/17/2014 Same as last inspection. (DWR Sutter Yard - A Freitag)12/16/2013 Slide gate stem is still bent. WS flapgate was closed. (DWR Sutter Yard - A Freitag)7/16/2013 Water flowing through pipe so screw gate definitely not closed. Was told NOV's have been sent for owner to replace stem. Flap gate gets closed for flood season. (DWR Sutter Yard - A Freitag)10/11/2012 Slide gate inoperable, but appears to be in closed position. Flap gate held in open position. Good candidate for video inspection when, if ever, dry. (DWR UCIP - Wylie)

Drainage ditch on LS toe.

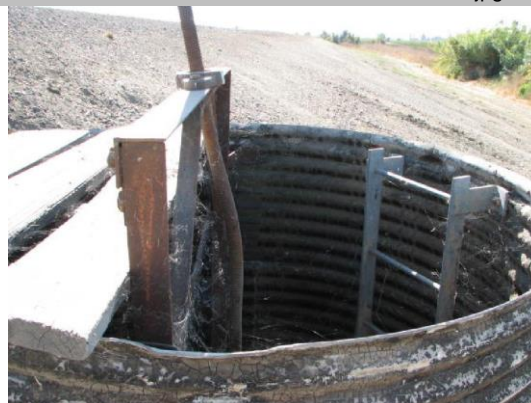
Photo 3 of 3 : UCIP\_SP\_2018\_51789\_69008.jpg

FS\_ID:51789  
DS\_ID:17154  
EP\_NO: 9388  
Repair Type: Urgent  
Crossing Status: Found  
UCIP Comments: 5/2/2017 WS slidegate stem is still bent, wheel to operate gate is missing. Needs a cover made for the standpipe to prevent falls. (DWR Sutter Yard- AFreitag)10/17/2016 Slide gate stem is still and the gate appears to be inoperable. (DWR Sutter Yard- AFreitag)5/31/2016 Slide gate stem is still bent. WS flap gate is chained open. (DWR Sutter Yard - afreitag)5/4/2015 Slide gate stem is still bent. Gate looks to be unable to close all the way. (DWR Sutter Yard - afreitag)6/17/2014 Same as last inspection. (DWR Sutter Yard - afreitag)12/16/2013 Slide gate stem is still bent. WS flapgate was closed. (DWR Sutter Yard - afreitag)7/16/2013 Water flowing through pipe so screw gate definitely not closed. Was told NOV's have been sent for owner to replace stem. Flap gate gets closed for flood season. (DWR Sutter Yard - afreitag)10/11/2012 Slide gate inoperable, but appears to be in closed position. Flap gate held in open position. Good candidate for video inspection when, if ever, dry. (DWR UCIP - wwylie)

Bent screw for slide gate at WS shoulder.

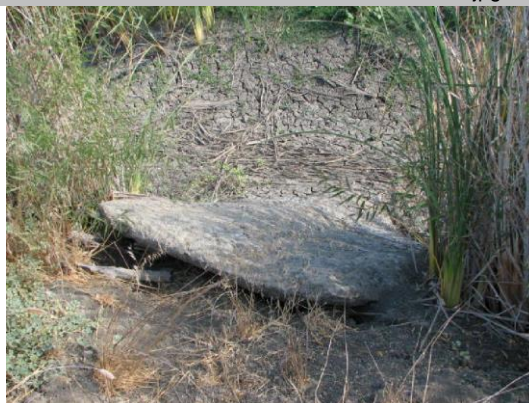
Photo 1 of 3 : UCIP\_SP\_2018\_51796\_69030.jpg

FS\_ID:51796  
DS\_ID:17191  
EP\_NO: N/A  
Repair Type: Non-Urgent  
Crossing Status: Found  
UCIP Comments: 5/2/2017 WS headwall and flapgate almost completely buried with only a small portion of the head wall visible. LS end is buried and unable to be located. (DWR Sutter Yard-AFreitag)10/17/2016 WS flap gate is still silted over and LS inlet is heavily vegetated and unable to be inspected. (DWR Sutter Yard-AFreitag)9/29/2016 Crosssing has been downgraded from Urgent to Non-Urgent WS flap gate is closed shut due to sediment build up. For flood season flap gate is required to be closed. Need to coordinate with owner to remove sediment from WS to have WS flap gate be operable after flood season. (DWR UCIP - omagana)5/31/2016 WS pipe end was mostly underwater but it appears to still be silted over. (DWR Sutter Yard - afreitag)5/4/2015 WS flapgate is blocked by sediment and unable to open. LS inlet is hidden by sediment and heavy vegetation and unable to be located. Needs to be cleared. (DWR Sutter Yard - afreitag)6/17/2014 Same as last inspection. (DWR Sutter Yard - afreitag)12/16/2013 Same as last inspection. (DWR Sutter Yard - afreitag)7/16/2013 Same as last inspection. (DWR Sutter Yard - afreitag)10/11/2012 Pipe is clogged at both the inlet and outlet. Good candidate for video inspection. (DWR UCIP - wwylie)

Apparent inlet clogged with concrete or grout on LS toe in drainage swale.

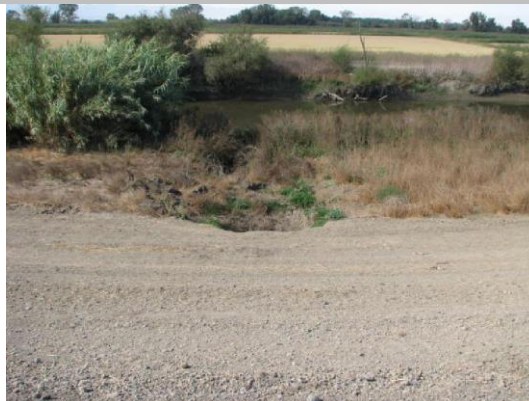
Photo 2 of 3 : UCIP\_SP\_2018\_51796\_69029.jpg

FS\_ID:51796  
DS\_ID:17191  
EP\_NO: N/A  
Repair Type: Non-Urgent  
Crossing Status: Found  
UCIP Comments: 5/2/2017 WS headwall and flapgate almost completely buried with only a small portion of the head wall visible. LS end is buried and unable to be located. (DWR Sutter Yard-AFreitag)10/17/2016 WS flap gate is still silted over and LS inlet is heavily vegetated and unable to be inspected. (DWR Sutter Yard-AFreitag)9/29/2016 Crosssing has been downgraded from Urgent to Non-Urgent WS flap gate is closed shut due to sediment build up. For flood season flap gate is required to be closed. Need to coordinate with owner to remove sediment from WS to have WS flap gate be operable after flood season. (DWR UCIP - omagana)5/31/2016 WS pipe end was mostly underwater but it appears to still be silted over. (DWR Sutter Yard - afreitag)5/4/2015 WS flapgate is blocked by sediment and unable to open. LS inlet is hidden by sediment and heavy vegetation and unable to be located. Needs to be cleared. (DWR Sutter Yard - afreitag)6/17/2014 Same as last inspection. (DWR Sutter Yard - afreitag)12/16/2013 Same as last inspection. (DWR Sutter Yard - afreitag)7/16/2013 Same as last inspection. (DWR Sutter Yard - afreitag)10/11/2012 Pipe is clogged at both the inlet and outlet. Good candidate for video inspection. (DWR UCIP - wwylie)

Outlet on WS toe.

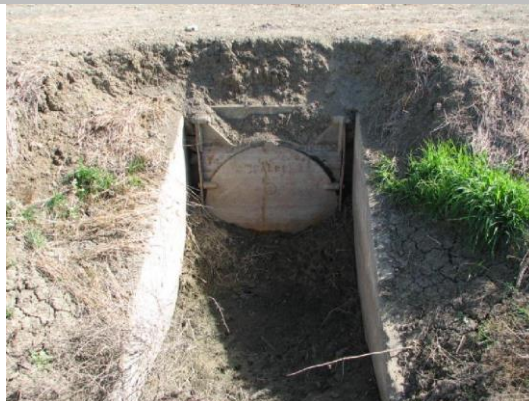
Photo 3 of 3 : UCIP\_SP\_2018\_51796\_69028.jpg

FS\_ID:51796  
DS\_ID:17191  
EP\_NO: N/A  
Repair Type: Non-Urgent  
Crossing Status: Found  
UCIP Comments: 5/2/2017 WS headwall and flapgate almost completely buried with only a small portion of the head wall visible. LS end is buried and unable to be located. (DWR Sutter Yard-AFreitag)10/17/2016 WS flap gate is still silted over and LS inlet is heavily vegetated and unable to be inspected. (DWR Sutter Yard-AFreitag)9/29/2016 Crosssing has been downgraded from Urgent to Non-Urgent WS flap gate is closed shut due to sediment build up. For flood season flap gate is required to be closed. Need to coordinate with owner to remove sediment from WS to have WS flap gate be operable after flood season. (DWR UCIP - omagana)5/31/2016 WS pipe end was mostly underwater but it appears to still be silted over. (DWR Sutter Yard - afreitag)5/4/2015 WS flapgate is blocked by sediment and unable to open. LS inlet is hidden by sediment and heavy vegetation and unable to be located. Needs to be cleared. (DWR Sutter Yard - afreitag)6/17/2014 Same as last inspection. (DWR Sutter Yard - afreitag)12/16/2013 Same as last inspection. (DWR Sutter Yard - afreitag)7/16/2013 Same as last inspection. (DWR Sutter Yard - afreitag)10/11/2012 Pipe is clogged at both the inlet and outlet. Good candidate for video inspection. (DWR UCIP - wwylie)

Concrete U shaped headwall and flap gate on WS toe.

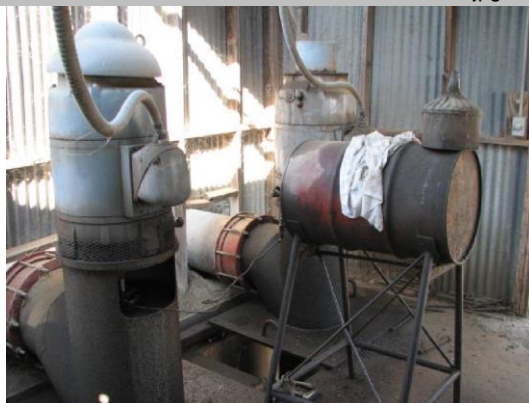
Photo 3 of 3 : UCIP\_SP\_2018\_51802\_69074.jpg

Pump for 20-inch pipe at left. See oil bouser and leakage around pumps.

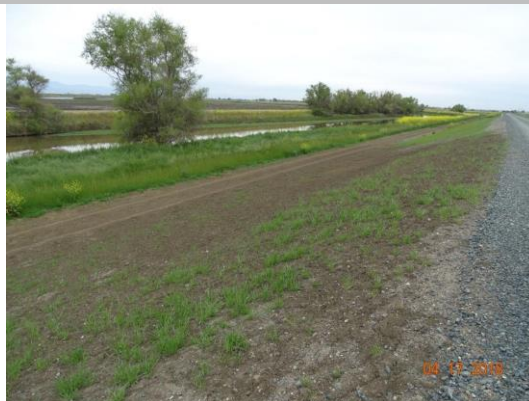
Photo 1 of 4 : SP\_2018\_MA0012\_299\_41\_20180430\_00084.jpg

View of the repaired erosion along the waterside slope. The erosion was repaired by Sutter Maintenance Yard.

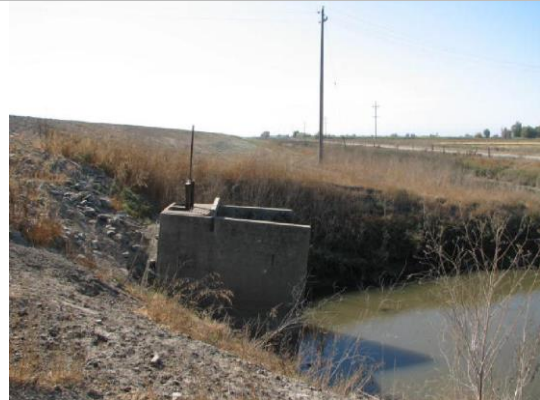
Photo 1 of 3 : UCIP\_SP\_2018\_51806\_69100.jpg

Tilting headwall on WS toe.

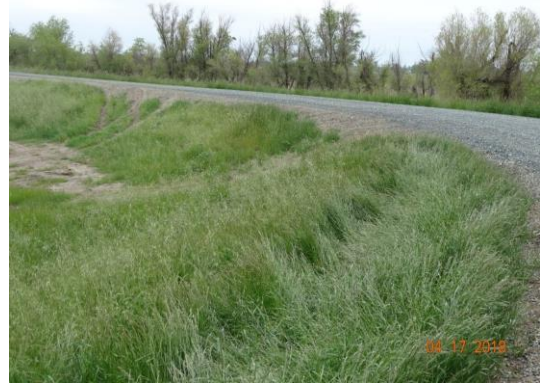
Photo 1 of 1 : SP\_2018\_MA0012\_299\_38\_20180430\_00085.jpg

View of the vehicle erosion along the landside slope.

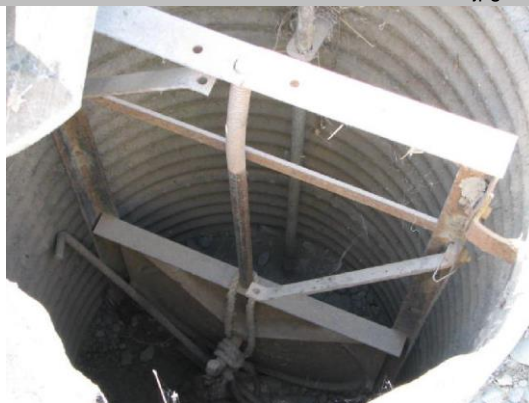
Photo 2 of 2 : UCIP\_SP\_2018\_51810\_69114.jpg

Bent and broken actuator on slide gate in 36-inch CMP. Pipe appears to be filled with soil.
